PRECISION HOME INSPECTION, INC.

CONFIDENTIAL INSPECTION REPORT

City/State: Cary, NC

Date of Inspection: 3/8/10

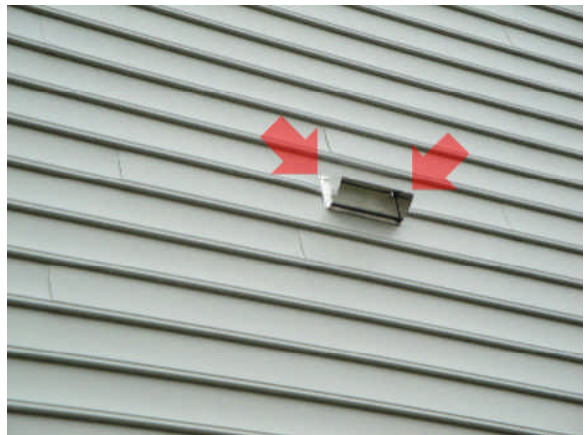
Material: Vinyl siding.
Condition: Top edge of kitchen stove vent hood is not properly recessed behind siding with "J" channel wrap for flashing purposes. It may be possible for water to get behind vent hood. Should be repaired as needed.

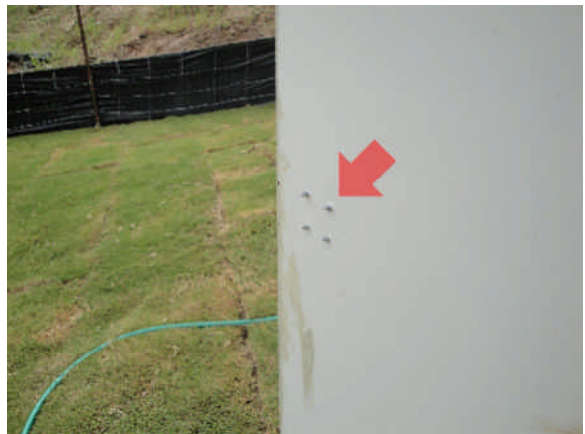
Condition: Noted screws protruding from crawlspace door. This could cause injury. Should be repaired as needed by a licensed general contractor.

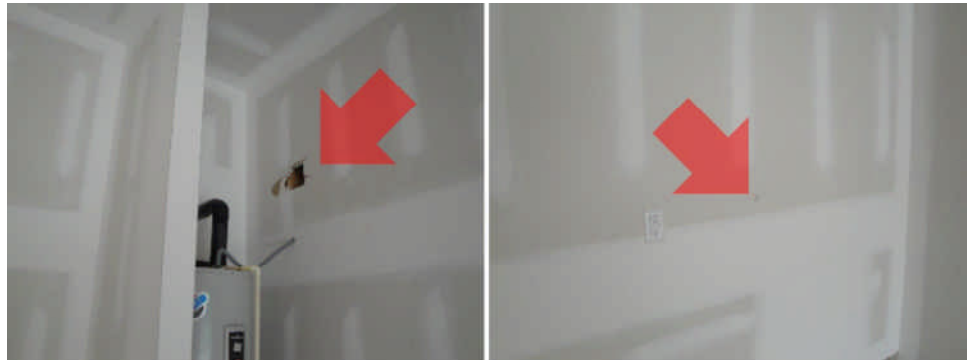
Firewall:

Repair is needed on garage fire protection by water heater and by receptacle. Repair any openings with approved materials to restore its fire rating.

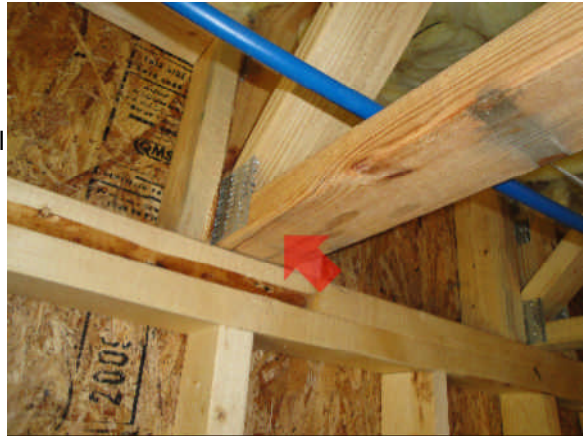
**First Floor
Structure:**

Noted cracked floor truss between vents at back right corner of house. Should be further evaluated and repaired as needed by a licensed general contractor.

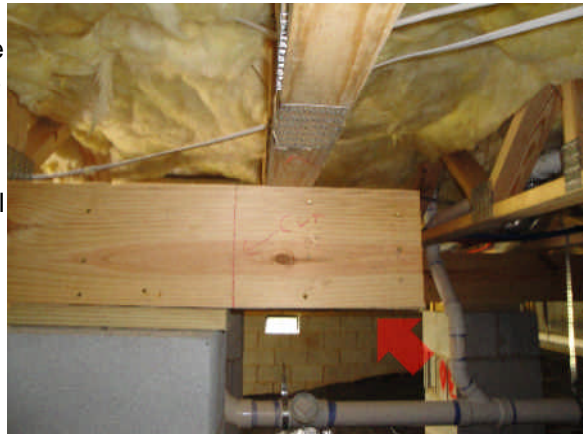
**Piers/Posts/
Girders:**

Noted extra length of girder that might need to be cut off as there is a truss over the end that does not have the proper point load support built in it. Should be further evaluated and repaired as needed by a licensed general contractor.

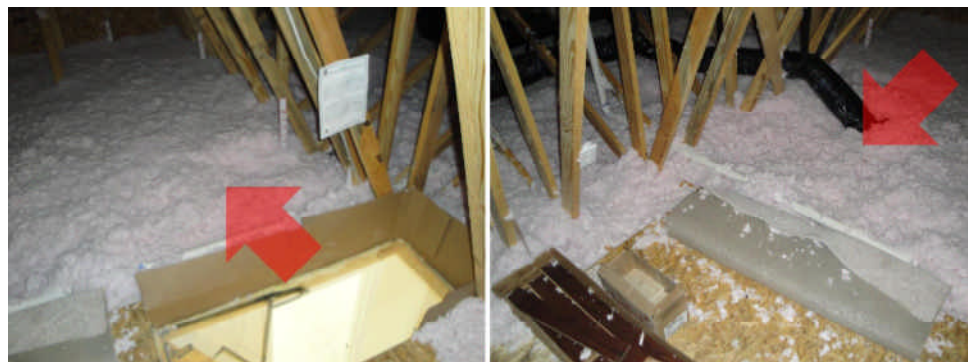
Fiberglass batt. Blown fiberglass.
Noted areas of low/missing insulation in attic. This has significantly reduced the original "R" value of 30 the house was built with or supposed to have been built with. Additional insulation should be installed by a professional insulation company to provide a uniform depth of 12" or "R-30".

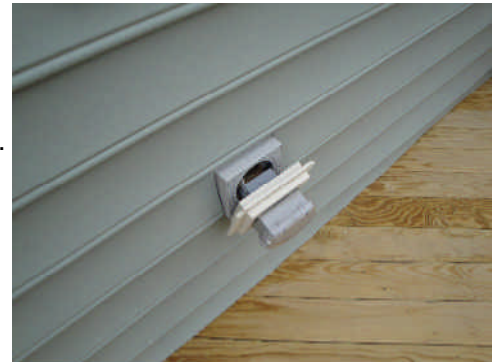
Copper. A representative sampling of switches and outlets was tested. As a whole, outlets and switches throughout the house are in serviceable condition. Noted loose receptacle box above deck. Should be further evaluated and repaired as needed by a licensed electrician.

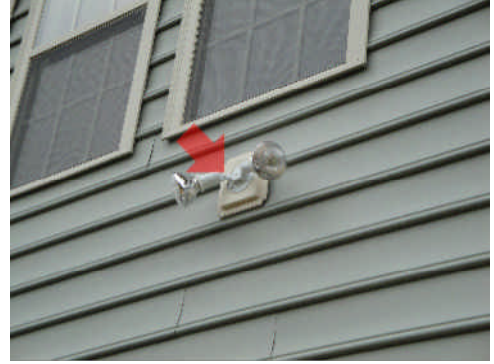
Lights, Switches

Flood light on back side of house is not installed properly and a gap is visible on left side. Should be further evaluated and repaired as needed by a professional vinyl siding installation company and licensed electrician.
